Contributions of in situ microscopy to the current understanding of stone biodeterioration

Summary. In situ microscopy consists of simultaneously applying several microscopy techniques without separating the biological component from its habitat. Over the past few years, this strategy has allowed characterization of the biofilms involved in biodeterioration processes affecting stone monuments and has revealed the biogeophysical and biogeochemical impact of the microbiota present. In addition, through in situ microscopy diagnosis, appropriate treatments can be designed to resolve the problems related to microbial colonization of stone monuments. [*Int Microbiol* 2005; 8(3):181-188]

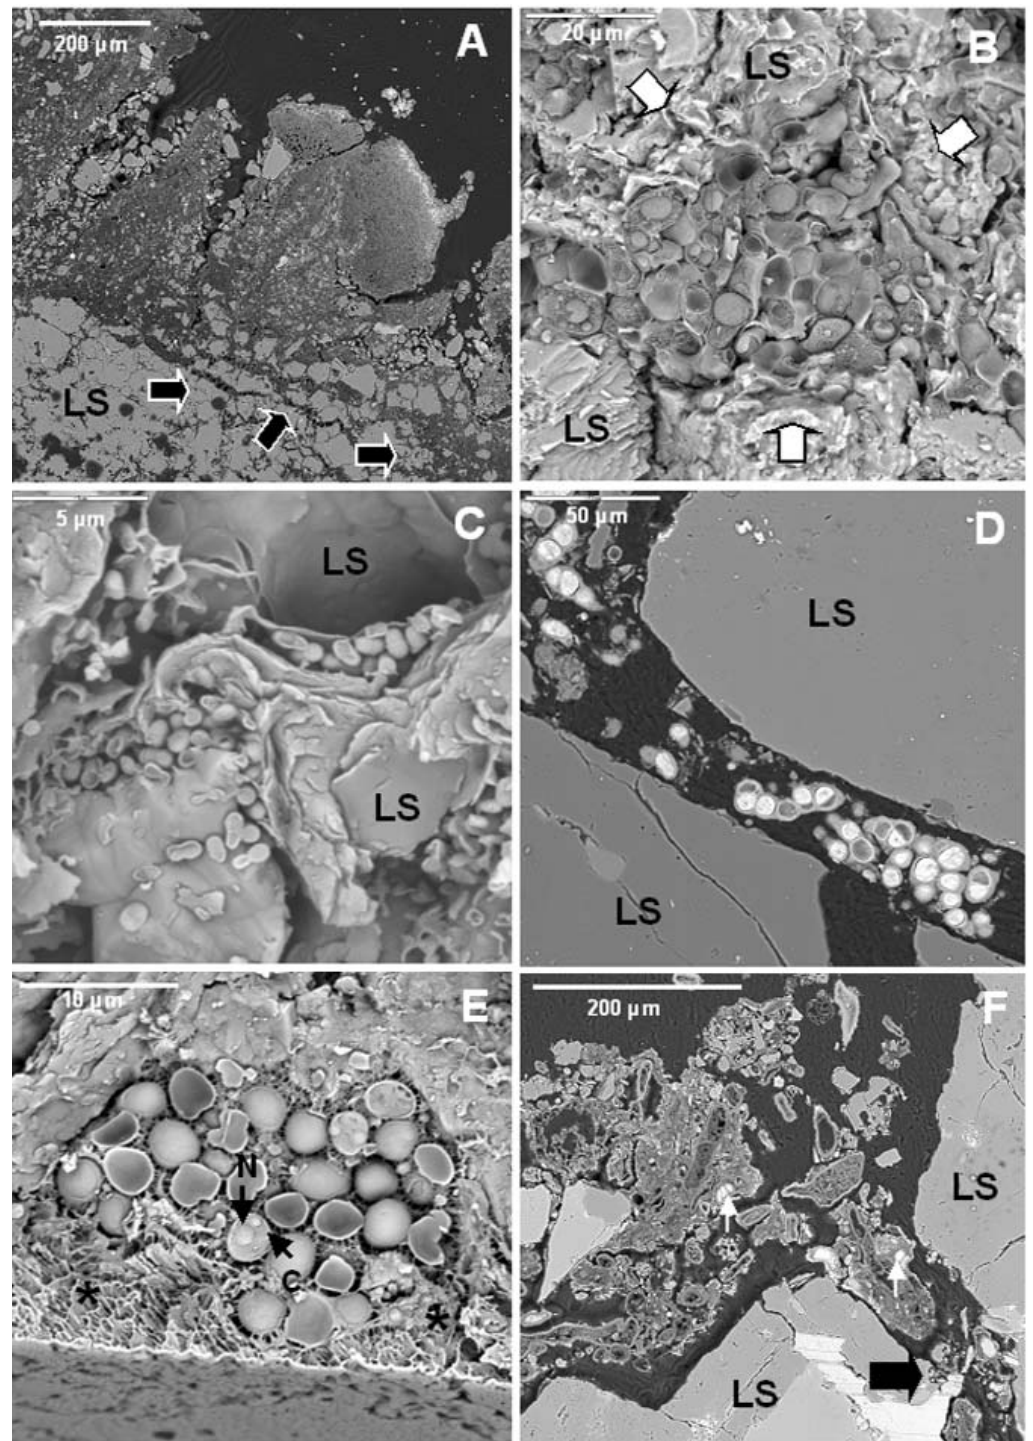
Fig. 1. Micrographs of various microorganism-rock interfaces. (A) SEM-BSE image of the interface formed by a crustose lichen thallus and the surface of a dolomitic rock. Black arrows indicate the endolithic penetration of mycobiont cells. (B) LTSEM image of free-living fungi in a cavity in dolostone. Arrows indicate the cavity. (C) LTSEM image of a group of bacterial cells colonizing dolostone. (D) SEM-BSE image of a fissure of granodiorite colonized by cocoid cyanobacteria. (E) LTSEM image showing a group of hydrated green alga embedded in a polymeric matrix (asterisks) taken from a cavity in dolostone; N, nucleus; C, chloroplast. (F) SEM-BSE image of the surface of a granodiorite bench showing the presence of mosses. Black arrow indicates the penetration of the moss into the stone, and white arrows the presence of associated cyanobacterial cells.

Lichens are regarded as primary colonizers and very aggressive agents in biodeterioration [31]. Figure 1A shows the surface of a dolomitic rock colonized by lichen thalli. SEM-BSE reveals the interface between the lichen and the underlying substrate, and also how the symbiont cells penetrate the rock (black arrows), causing extensive disaggregation of the dolomitic rock.

In addition to lichenized fungi, other fungi have been also detected in monument stone, such as the fungus embedded in a mineral matrix, shown in Fig. 1B (arrows). Fungal types associated with monument stone vary considerably [27]. In this regard, it is now widely accepted that rock surfaces are common habitats for chemoorganotrophic and chemolithotrophic bacteria, actinomycetes, and especially fungi [30,44]. Heterotrophic bacteria are frequently observed in close association with the rest of the microorganisms in the altered zone [9,18], but they may also form independent colonies (Fig. 1C).

In addition to lichen photobionts, other phototrophic microorganisms can colonize monument rock. Free-living cyanobacteria and algae have been observed on rock surfaces [2,33,35,39] and inside fissures and cavities in carbonate [7,9,34,40] and granite rocks [18]. Figure 1D is an SEM-BSE image showing a fissure in a granodiorite rock colonized by coccoid cyanobacteria. Figure 1E shows a hydrated group of algal cells occupying a cavity in the lower surface of a detached dolostone, as fragment visualized by LTSEM. In these cells, the nucleus and chloroplast can be distinguished, showing the ultrastructural resolution ability of this technique.

Mosses commonly appear also in the proximity of microorganisms colonizing lithic substrates. Figure 1F shows mosses at a granodiorite bench. Cyanobacterial cells were observed associated with the moss cells (white arrows). The trapping of atmospheric dust by mosses can favor the presence of associated microbiota and also lead to the formation of enough substrate so that other plants can grow there [31].

Extracellular calcium carbonate deposits have been attributed to the presence of cyanobacteria in the biodeterioration of the Tower of Belem in Lisbon, Portugal [7]. Calcification of cell walls and biomineralization processes in carbonate nodules have been linked to the microbiota present in the Roman Cathedral of Jaca, Spain [8]. Calcium oxalate has been also observed in lichen-colonized monument rocks [10]. Figure 1F

shows, among phylidium moss, calcium-rich minerals resulting from the biomineralization process. High calcium levels in plants have been related to the damage they inflict on calcareous rocks [31]. Biomineralization processes, the deposition of clay and quartz particles from the environment and, in polluted areas, also the deposition of toxic pollutants have been implicated in the formation of aesthetic patinas on monuments [22,30,35].

In Fig. 1E, a group of algae embedded in a polymeric matrix (asterisks) inside a rock cavity can be clearly visualized. Although the amount of EPS depends on the type of biofilm and its location, the matrix is always an essential component of the biofilm, both at epilithic and at endolithic sites. In complex communities, the extracellular matrix comprises the EPS produced by the different resident microorganisms. Biologically initiated chemical effects on rocks are frequently connected to the presence of EPS that act as sorbents of metal ions. However, EPS actions have to be interpreted also in relation to the physical damage, since this component undergoes substantial volume changes during cycles of drying and rewetting and of freezing and thawing; this, in turn, causes loosening of the stone grains. The hygroscopic properties of EPS and the consequent higher water content of the microenvironment around microbial communities may also enhance nutrient availability and interactions among microorganisms [50].

roles of microorganisms in biodeterioration processes. The cyanobacteria shown in Fig. 1D are chasmoendolithic microorganisms, since they seem to be occupying pre-existing fissures in the rock. The green algae observed in Fig. 1E can be designated as cryptoendolithic because they occupy a cavity in the rock. Euendolithic cyanobacteria are seen in Fig. 4A. The effects of chemical attack on the stone are clearly visible in places where the cavity harbors the microorganisms and takes on the typical pear shape of their colony [7]. In some cases, it is difficult to attribute an euendolithic nature to the microorganisms. Some of the components of certain biofilms are cryptoendolithic (Fig. 2A), meaning that the microorganisms colonize cavities in the rock, but the inferred substrate-altering capacity of some suggests a euendolithic niche.

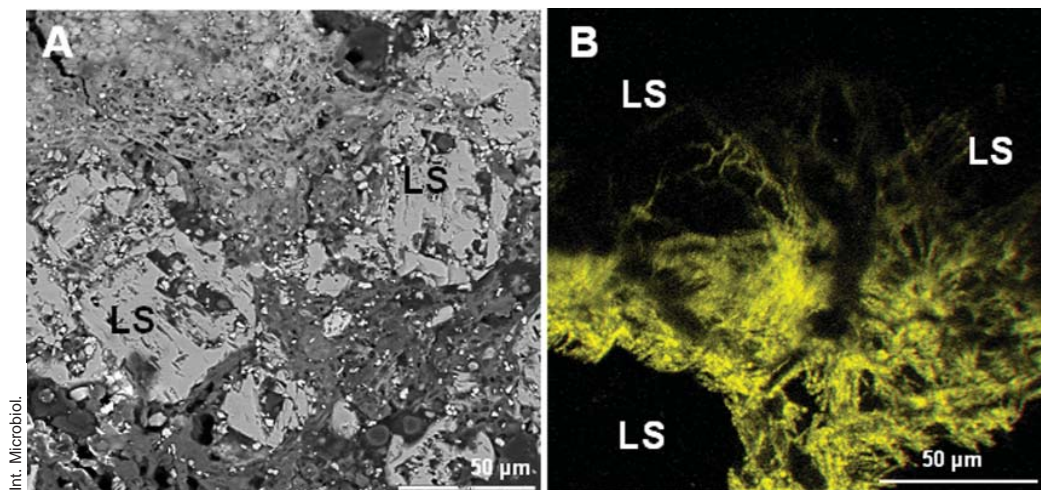
Fig. 2. Micrographs of colonizing endolithic fungi. (A) SEM-BSE image of cryptoendolithic fungi in a cavity found in limestone, under a lichen thallus. (B) Three-dimensional CSLM image of the endolithic fungal colonization of limestone.

fungi. Lichenized fungal cells penetrate the spaces between rock grains and along mineral exfoliation planes. This penetration, along with growth of the fungus within the substrate (Figs. 2A,B), leads to rock fragmentation. This is a common phenomenon observed in several types of rock, such as limestone [8,9,18], marble [32], granite [5,17,43], or sandstone [28]. Black fungi have also been noted to cause physical damage to stone due to their efficient rock-penetrating capacity [19,25]. Physical damage caused by poikilotroph microcolonial micromycete fungal biofilms in rocks was recently demonstrated by microscopy and characterization of the physical properties of these colonies [20].

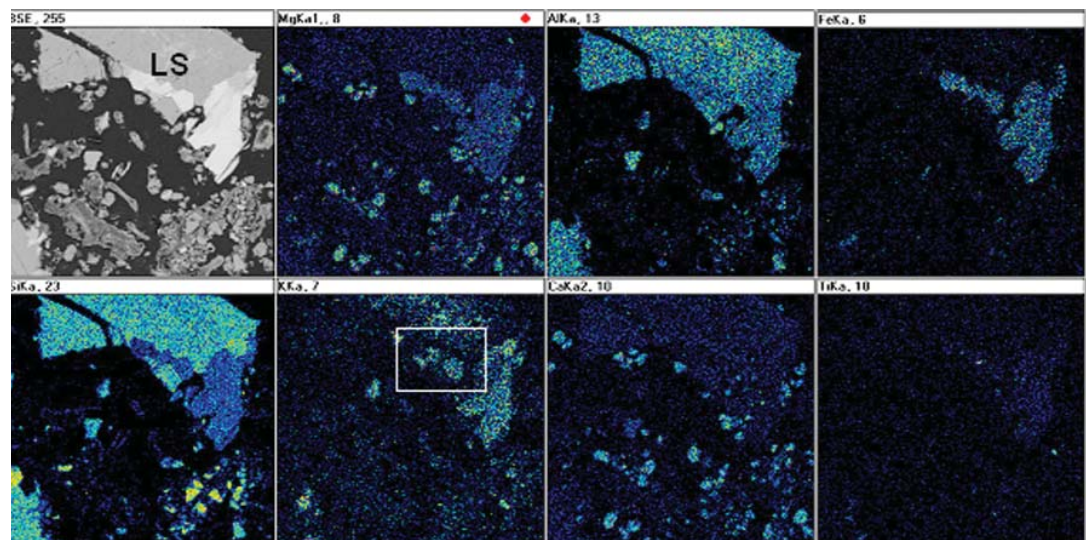
Fig. 3. SEM-BSE image and EDS spatial distributions of magnesium (Mg), iron (Fe), calcium (Ca), silicon (Si), aluminium (Al), titanium (Ti) and potassium (K) in granodiorite stone colonized by mosses.

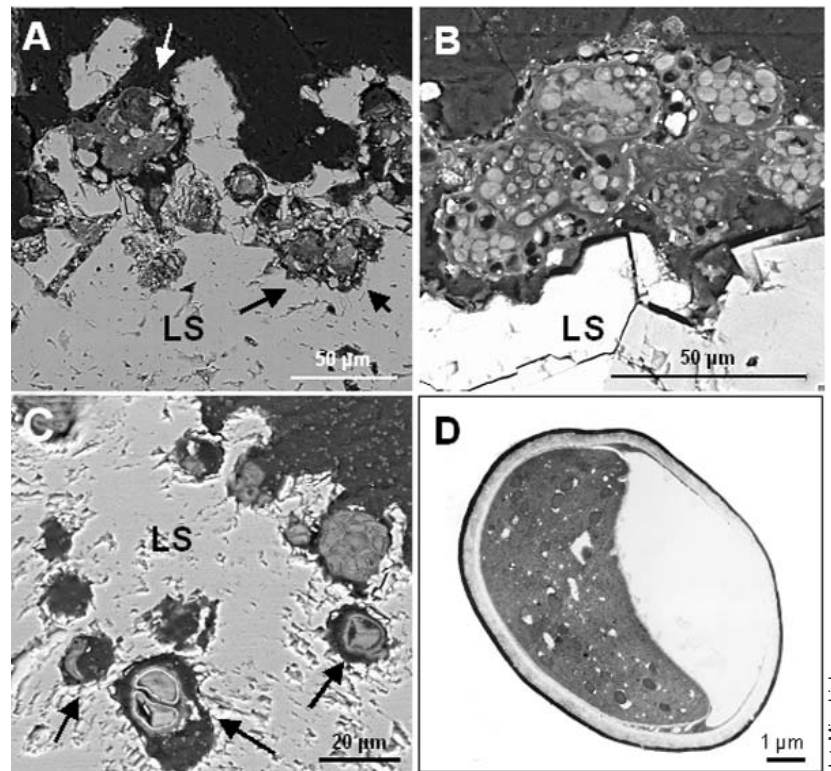
Fig. 4. Micrographs of epilithic and endolithic microorganisms. (A) SEM-BSE image showing the epilithic (white arrow) and endolithic (black arrows) microbial colonization of a stone from a marginal zone of a disused quarry. (B) SEM-BSE image showing a colony of epilithic cyanobacteria in a rock sample taken from a quarry abandoned 25 years ago. (C) SEM-BSE image of a euendolithic cyanobacterium after treatment with Preventol R80. Arrows indicate cells showing signs of degeneration. (D) TEM image of a cyanobacterial cell after treatment with Preventol R80.

The images obtained in this study showed euendolithic cyanobacteria with collapsed protoplasts and others that had completely lost their cell structure after treatment with Preventol R80 (Fig. 4C). The TEM image of Fig. 4D confirmed plasmolysis and the complete loss of cell organization in cells treated with Preventol R80. The lack of resistant forms in the rock after treatment is also important for estimating the effectiveness of the treatment. These measures must be combined with strategies designed to impair environmental conditions that will stimulate microbial colonization. Otherwise, new forms of biological colonization will arise sooner or later.
